# The River Dee Trust

## **Report on the impact of Large Woody Structures on the Muick 2020-2022**

February 2023

# Impact of Large Woody Structures on the Muick, 2020-2022

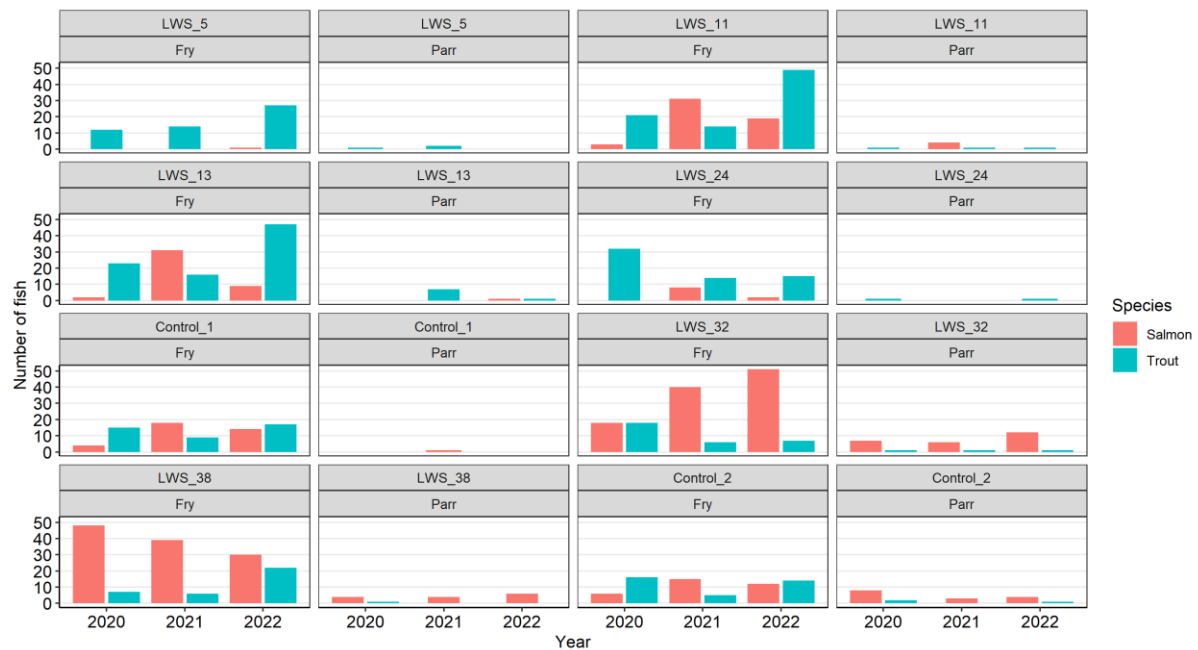
**Figure 6:** Total number of salmon (red) and trout (blue) fry and parr caught by electrofishing at each 200m<sup>2</sup> site. 2020 is before addition of LWS.

The change in total fry numbers cannot be attributed to an increase in just one species and each site shows a different pattern in numbers most likely related to habitat type. At LWS\_5, the most upstream location, almost all fish captured were trout and the number of trout fry have increased each year. At LWS\_32, salmon fry numbers increased yearly while trout numbers remain low. Similarly, despite the low numbers of parr, there is an upstream-downstream pattern in parr numbers with trout parr more frequently caught in the upstream sites and increasing numbers of salmon parr caught in the downstream sections (**Figure 6**).

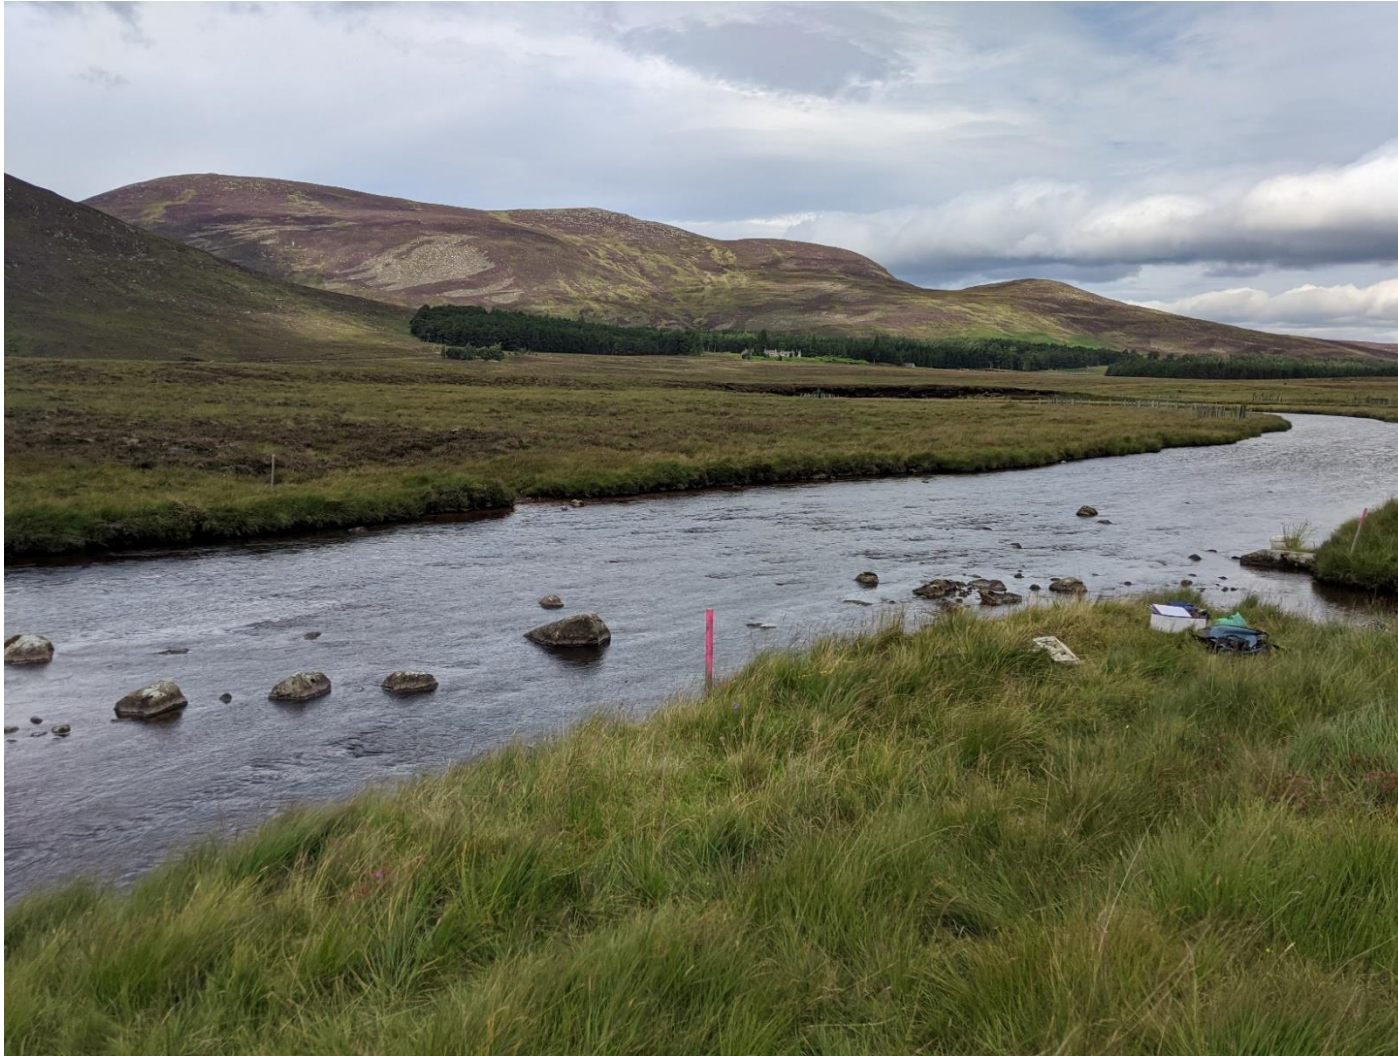
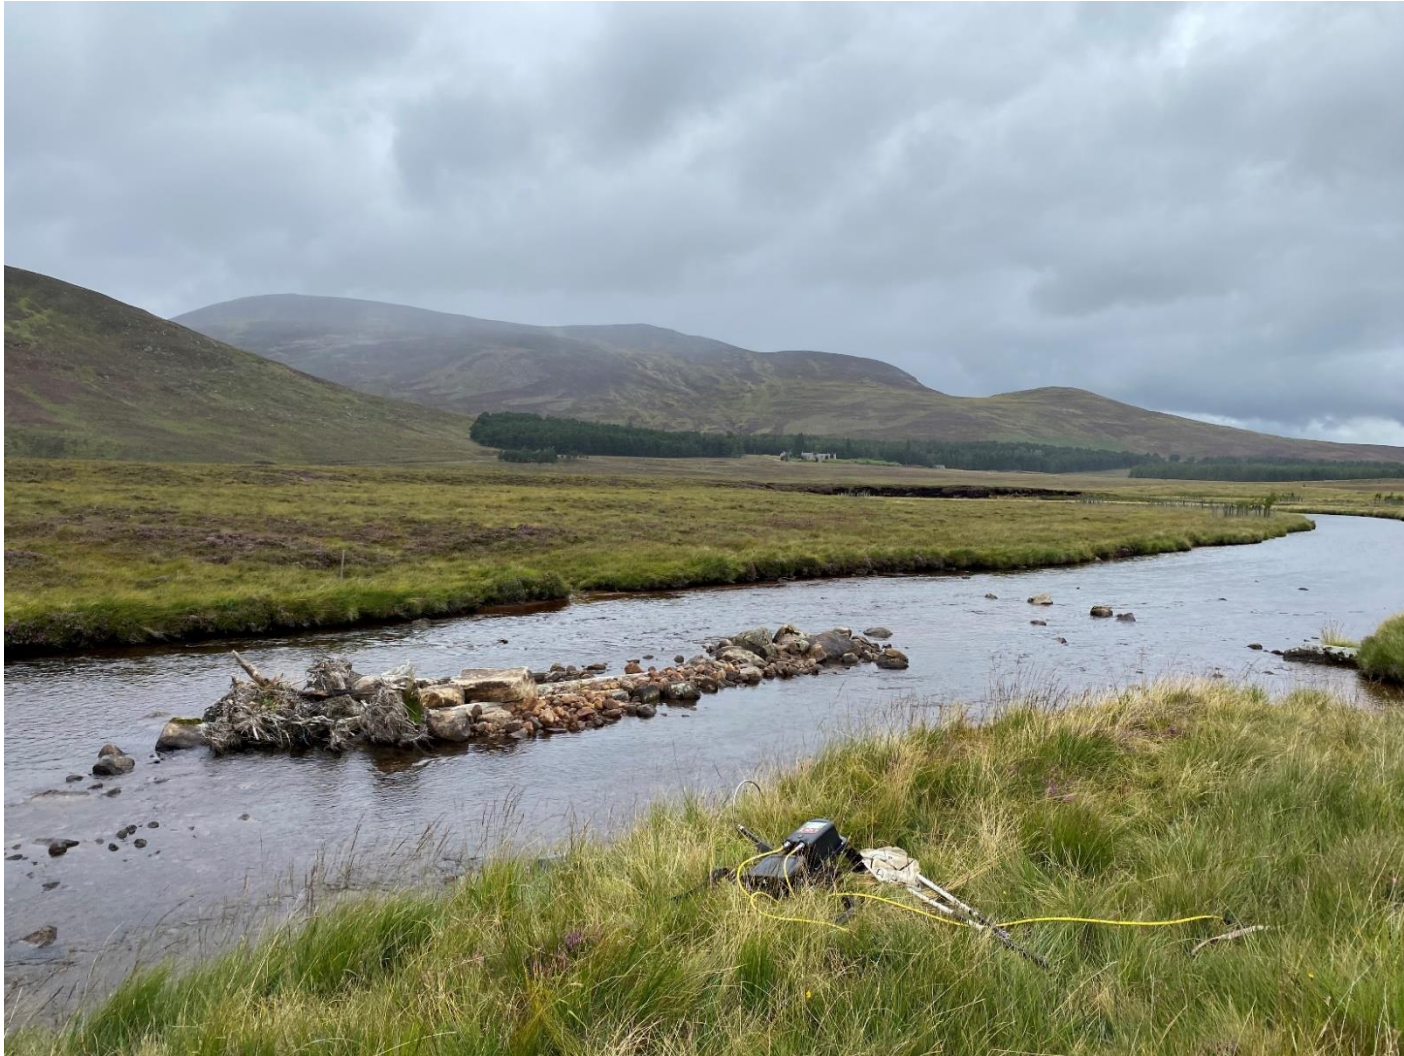
**Appendix 1:** Fixed Point Photography of LWS\_13, a midstream structure. Photos from 2020 and 2022

The transect data and photography of the site highlight some of the hydro-morphological changes caused by the LWS (see **Appendix**). Prior to their addition the Muick had limited structural habitat within the river or at the bank edge due to a lack of bankside vegetation. The addition of LWS leads to suitable redd habitat being formed just downstream of the structure and most redds recorded in the Muick have been associated with LWS. Equally, the root wads and boulders that help to fix the LWS in place lead to deep scours appearing which provide refuge for fish from predators.

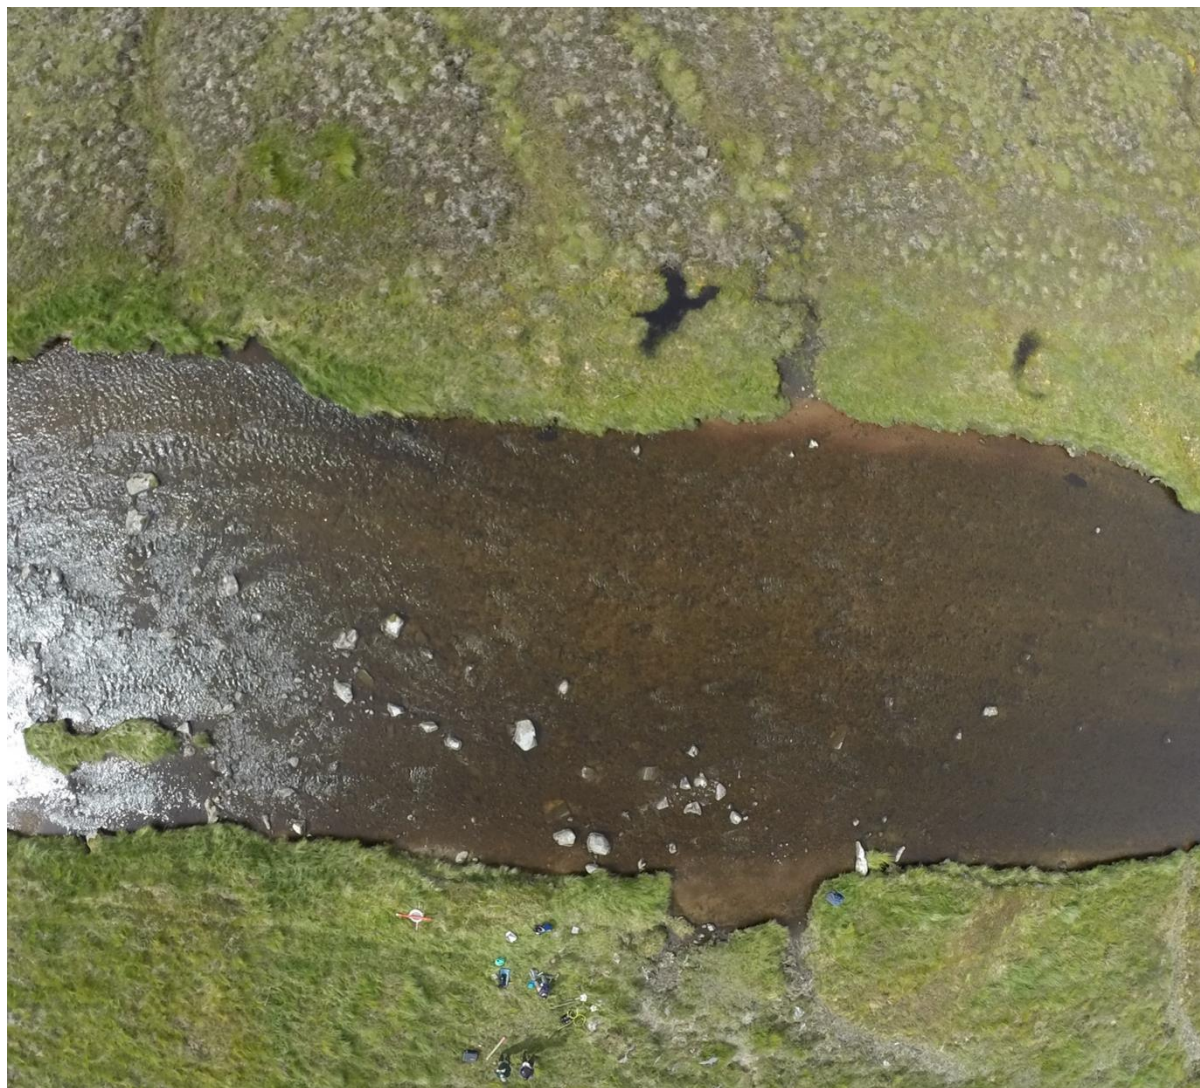
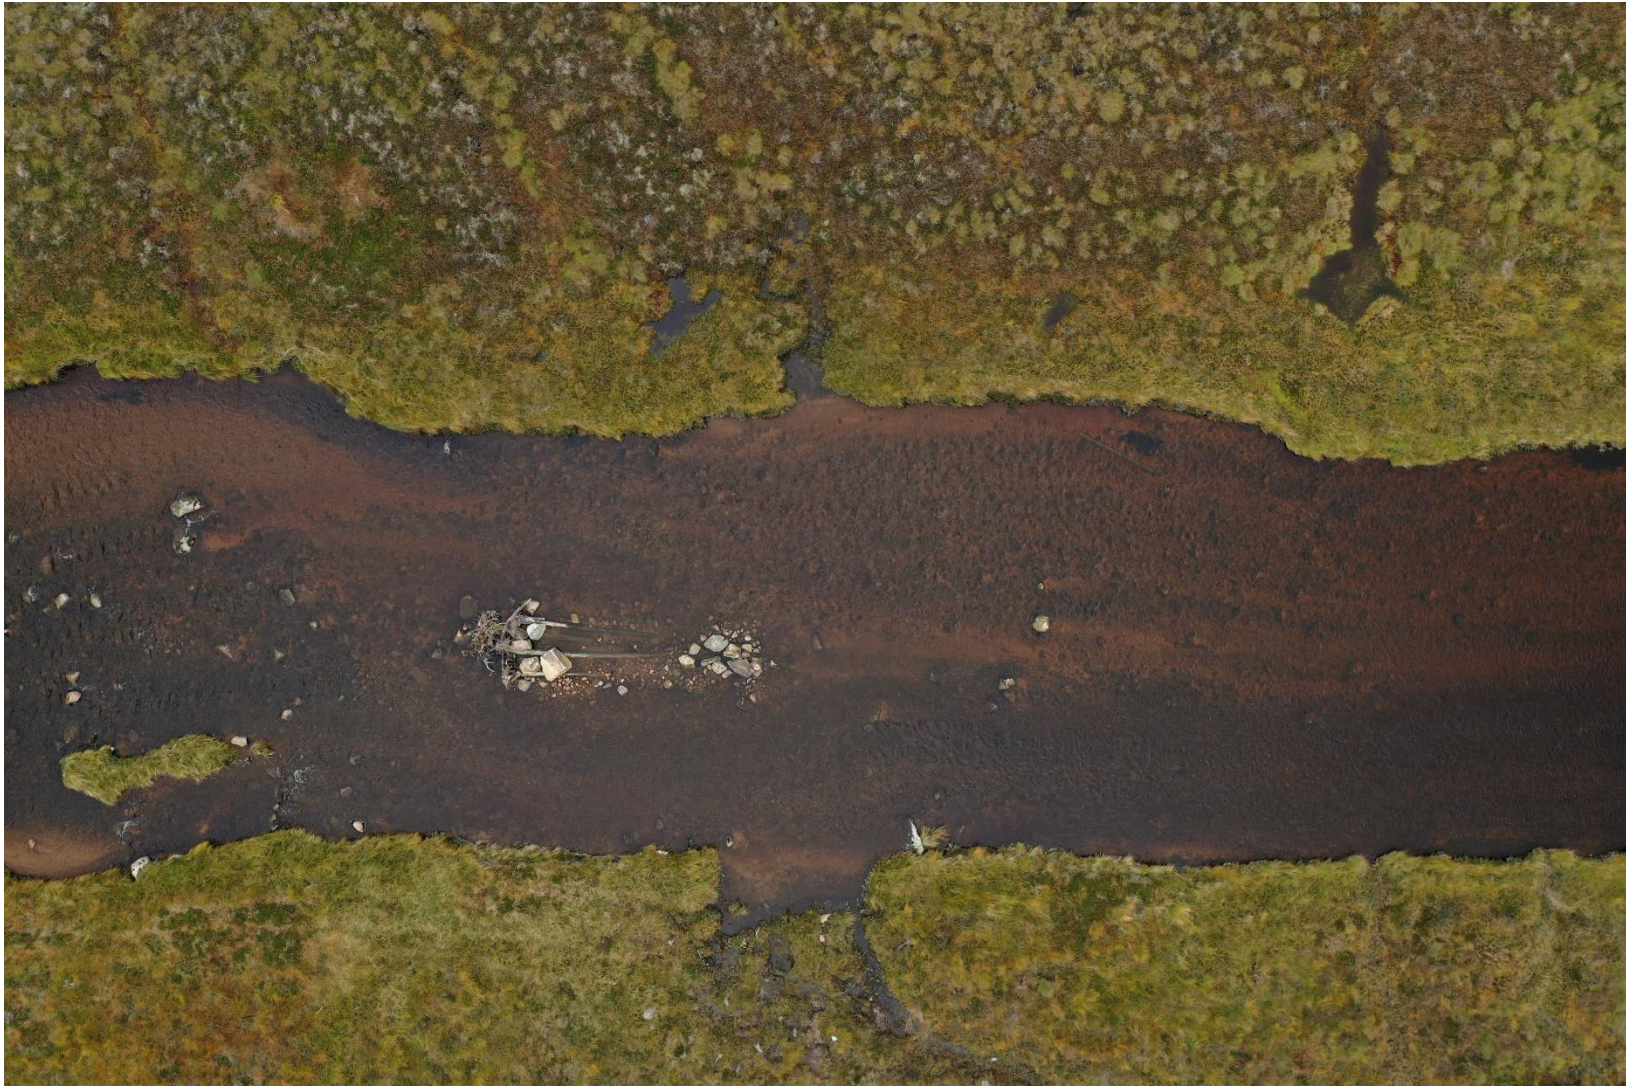
**Appendix 2:** Aerial photography of LWS\_13 taken in 2020 and 2022.
